CORROSIVE-WEAR OF BUOY CHAIN

**RICHARD R. BROWN
AND
CRAIG A. KOHLER**

**U.S. COAST GUARD RESEARCH AND DEVELOPMENT CENTER
AVERY POINT, GROTON, CONNECTICUT 06340-6096**

**FINAL REPORT
JANUARY 1988**

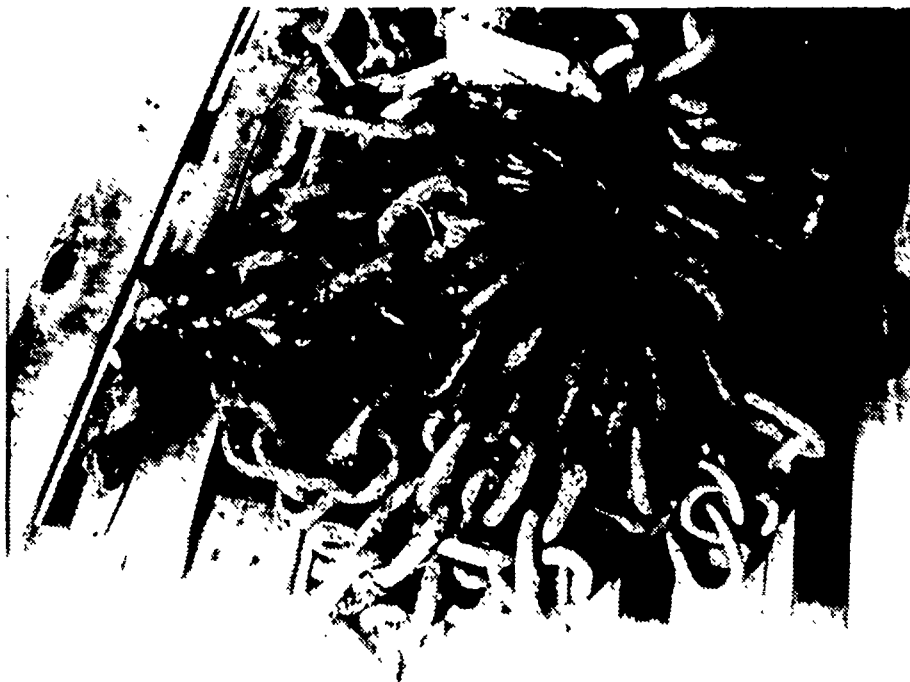
FIGURE 9. Chain appearance after two years of exposure, 1022 steel.

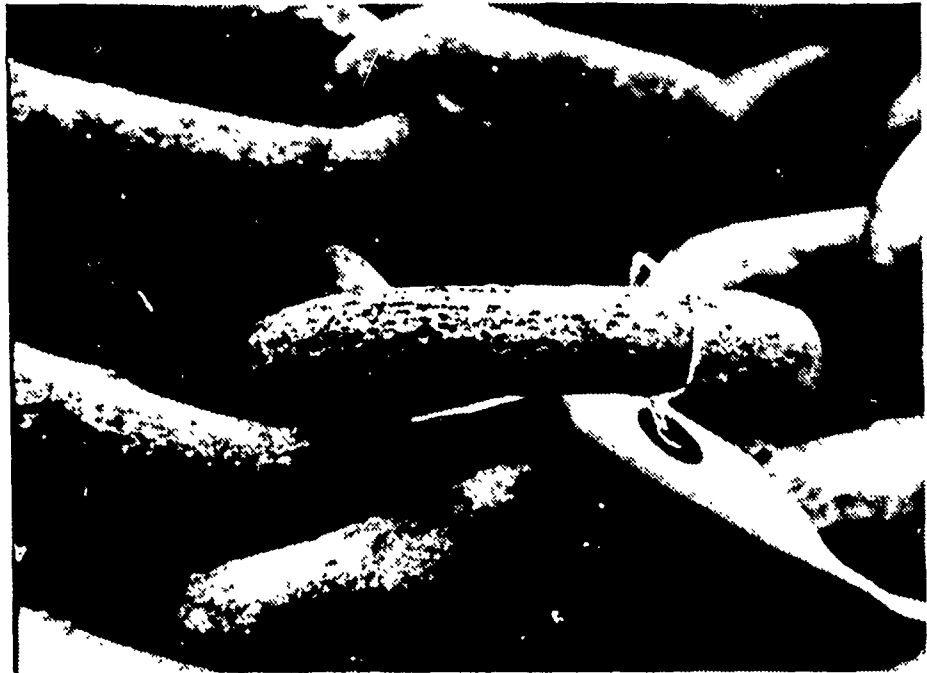
FIGURE 16. 1022 chain in chafe section with shallow elongated pits.
